TECHNICAL REPORT N-70-10

**SURVEY OF GULF COAST
STRUCTURAL DAMAGE RESULTING FROM
HURRICANE CAMILLE, AUGUST 1969**

By U. S. Army Engineer Waterways Experiment Station, Vicksburg, Mississippi

April 1970

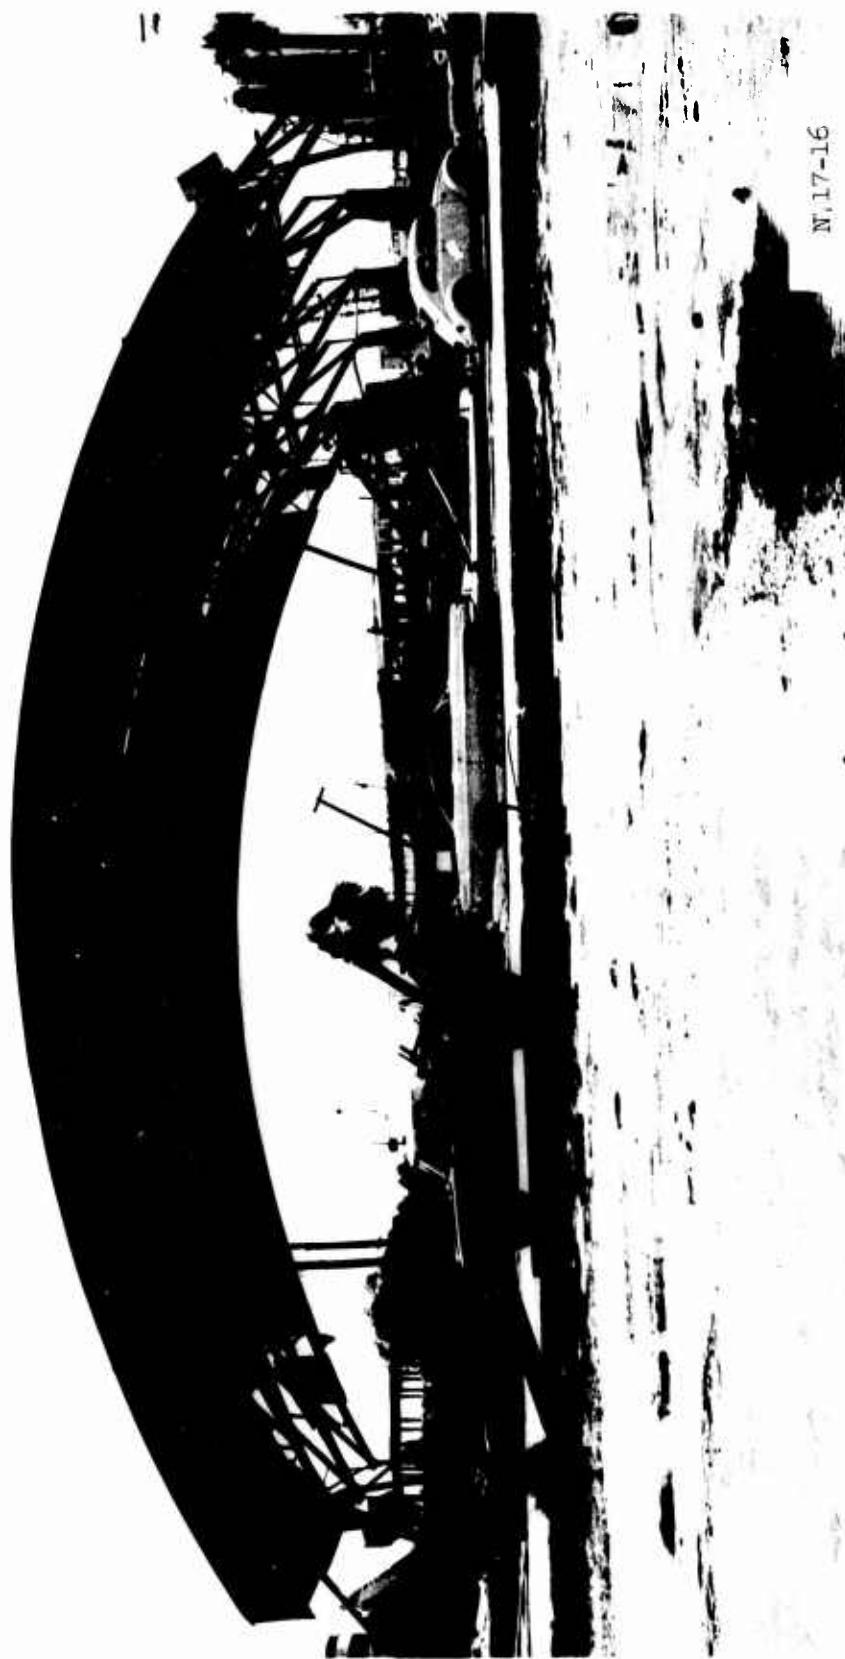
The steel arch remained standing despite the loss of two pipe column supports at the northeast corner (corner nearest the camera and to the left in Figure 3.13) and the dropping of the other three columns on the east side. Some roofing was torn off the west side of the arch (Figure 3.14). The middle pier supporting the west end of the arch was badly damaged

Figure 3.13 Marine Life steel arch.

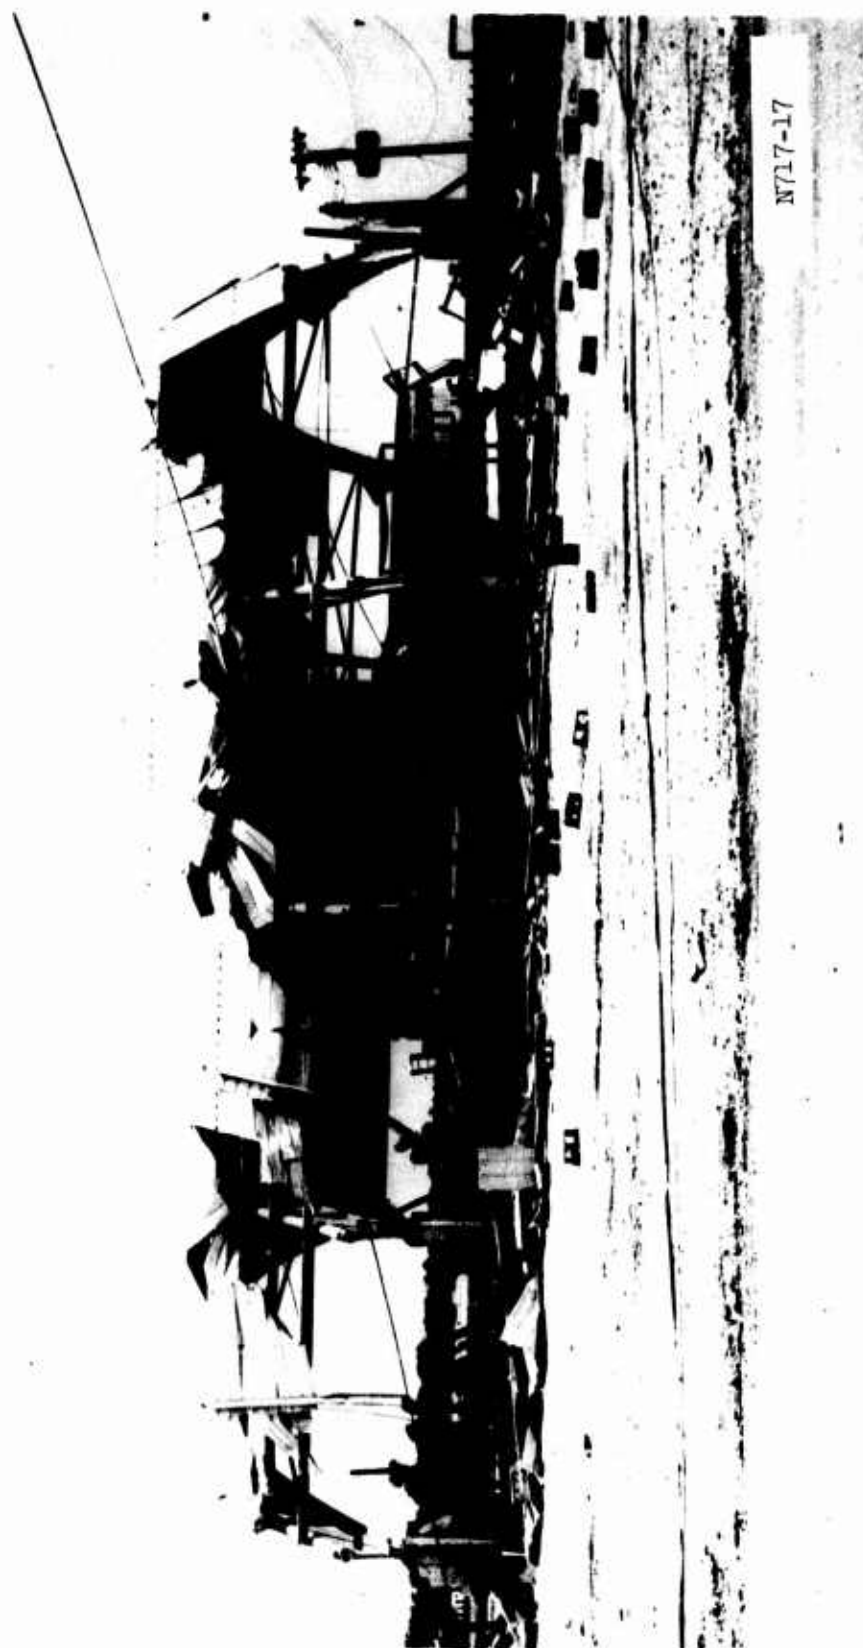
Figure 3.14 Marine Life arch.

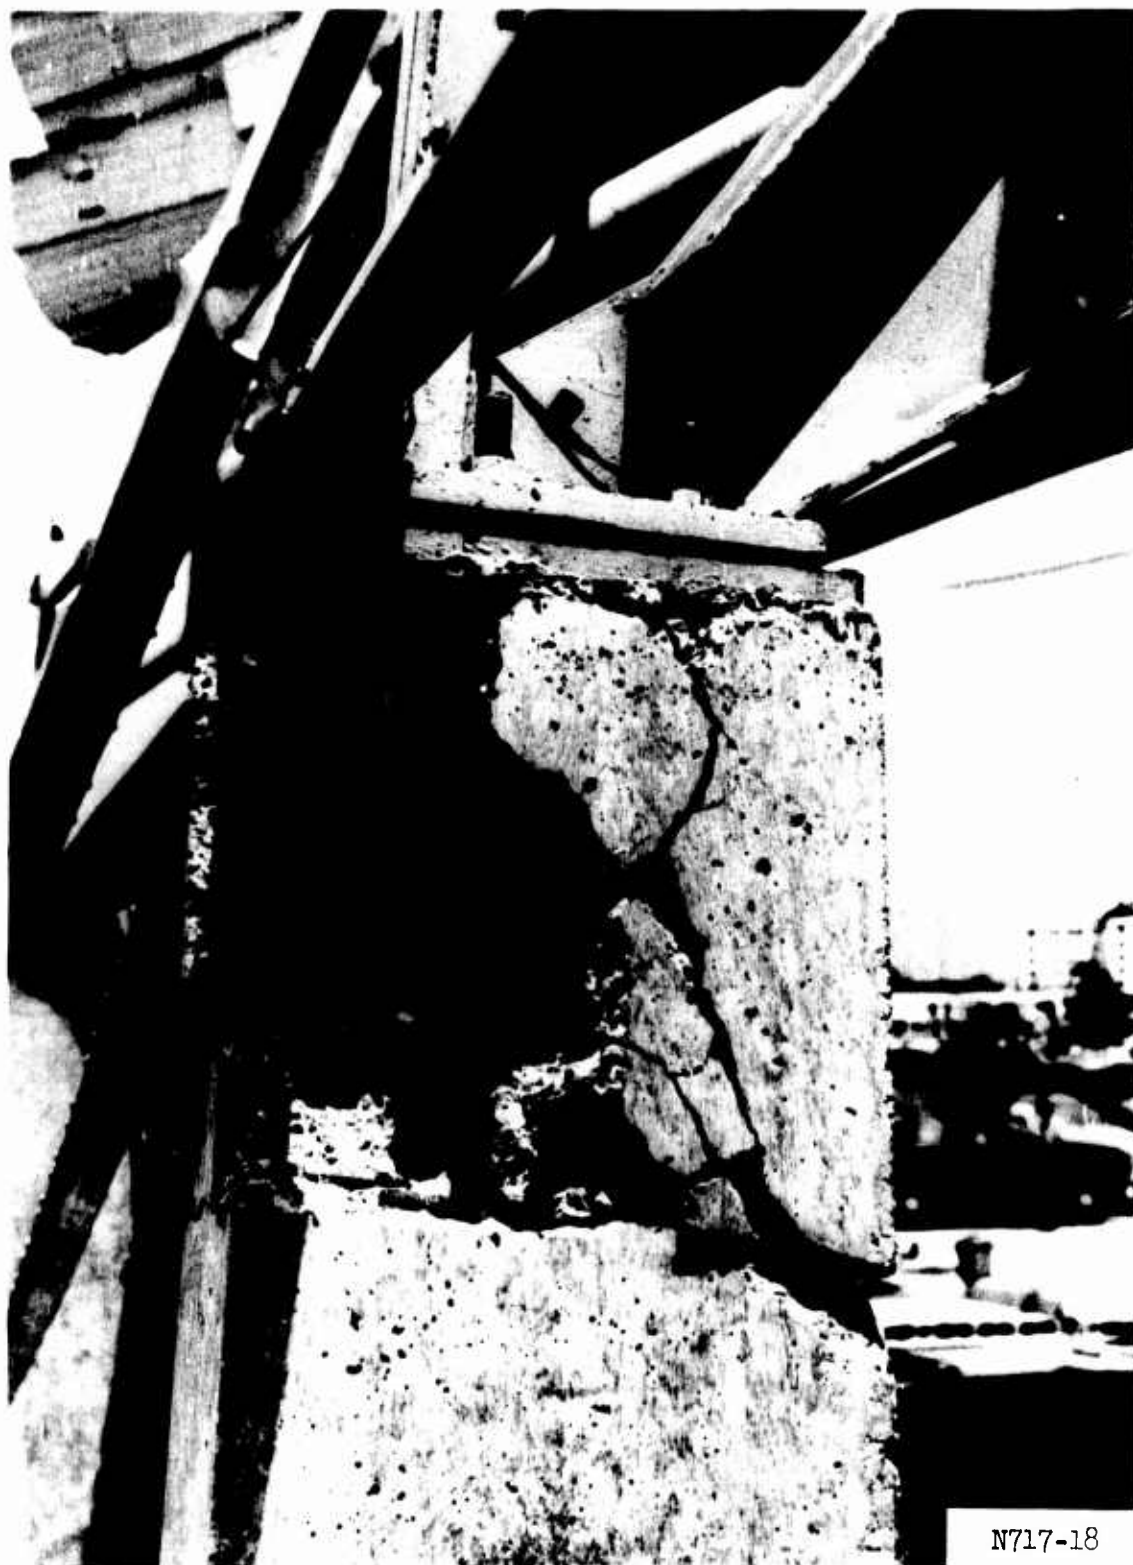
(Figure 3.15) and no doubt would have functioned better had more column ties been included near the top of the pier.

Figure 3.15 Center pier supporting west end of arch, Marine Life.

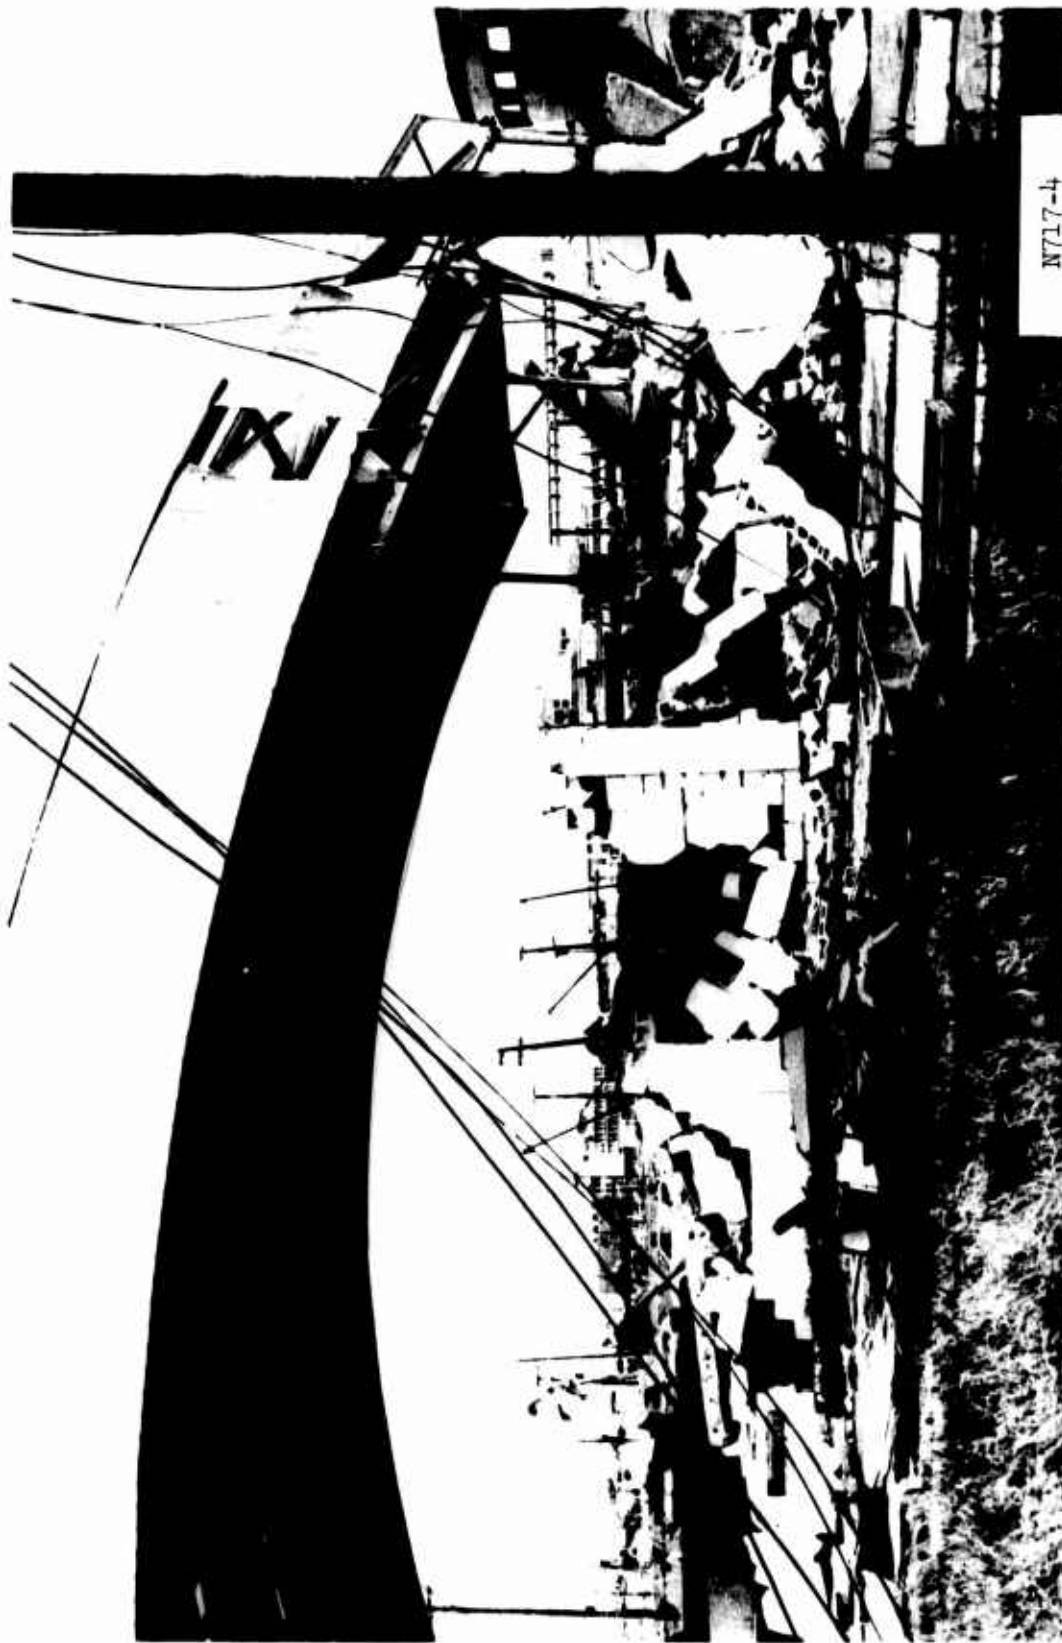
The approximate maximum water wave level during Hurricane Camille is the top of the bent cladding on the arch (see Figure 3.16).

Figure 3.16 Southeast corner of Marine Life arch.

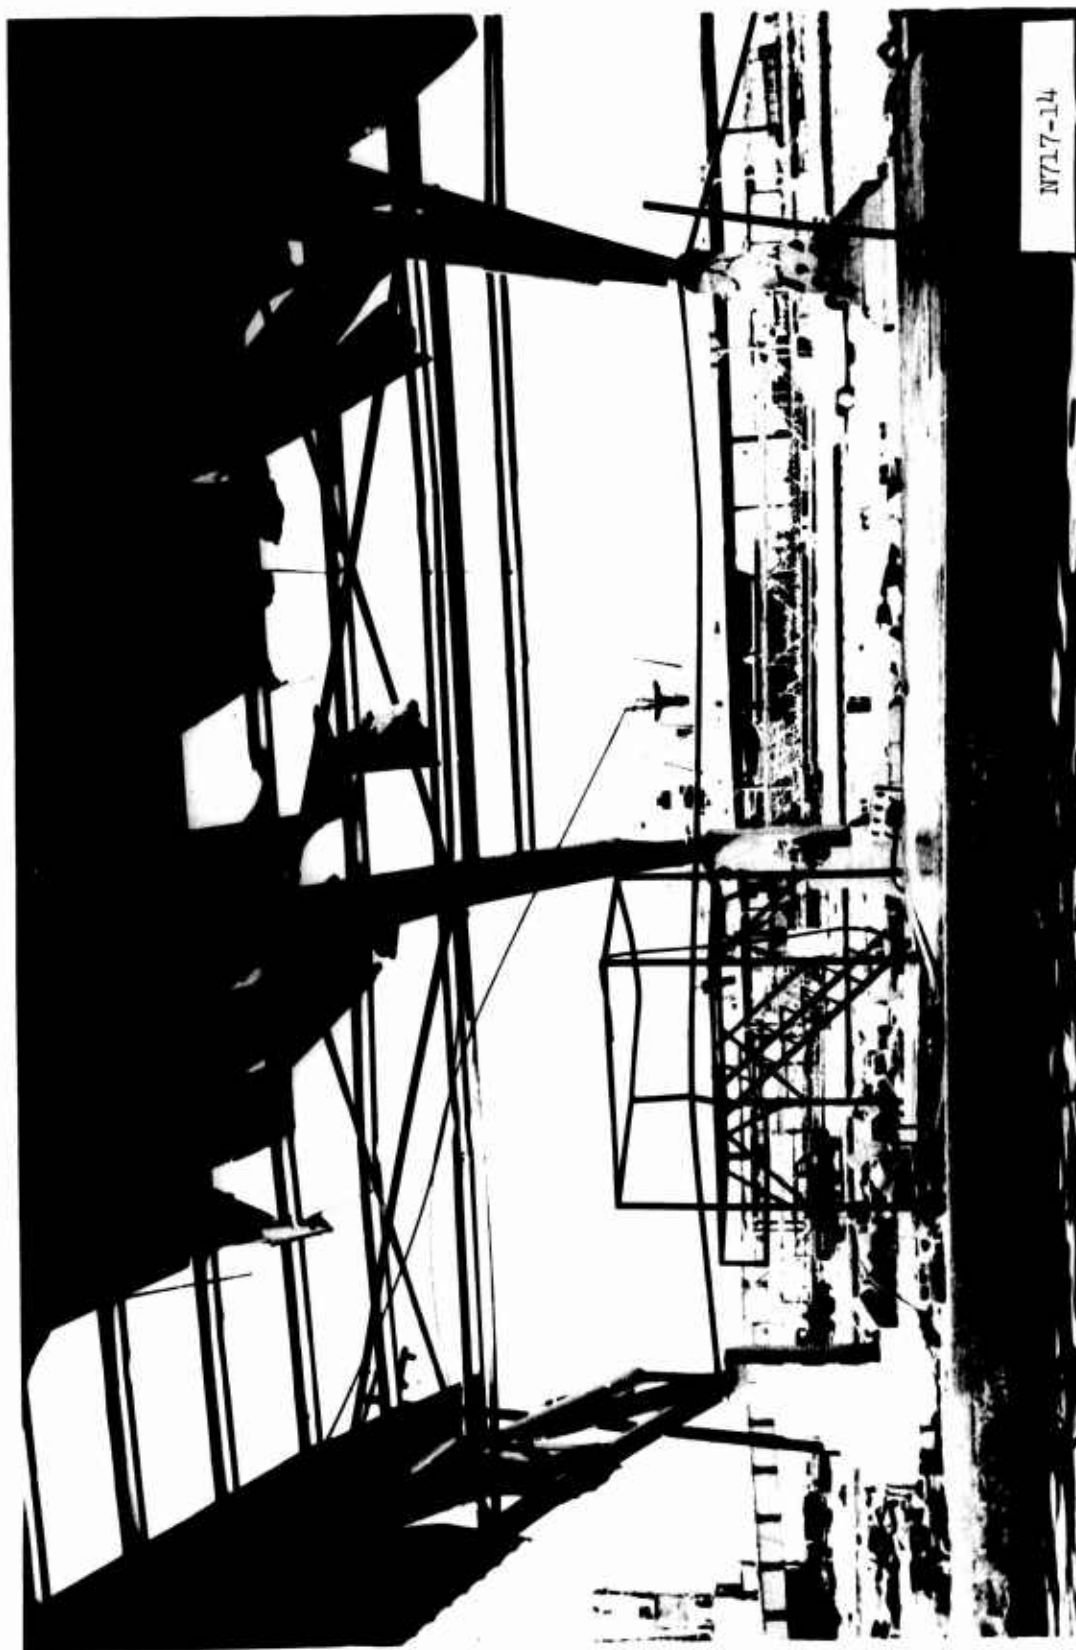
The block wall along the west side of the arch was almost completely destroyed (Figure 3.17).

Figure 3.17 West end of Marine Life arch.

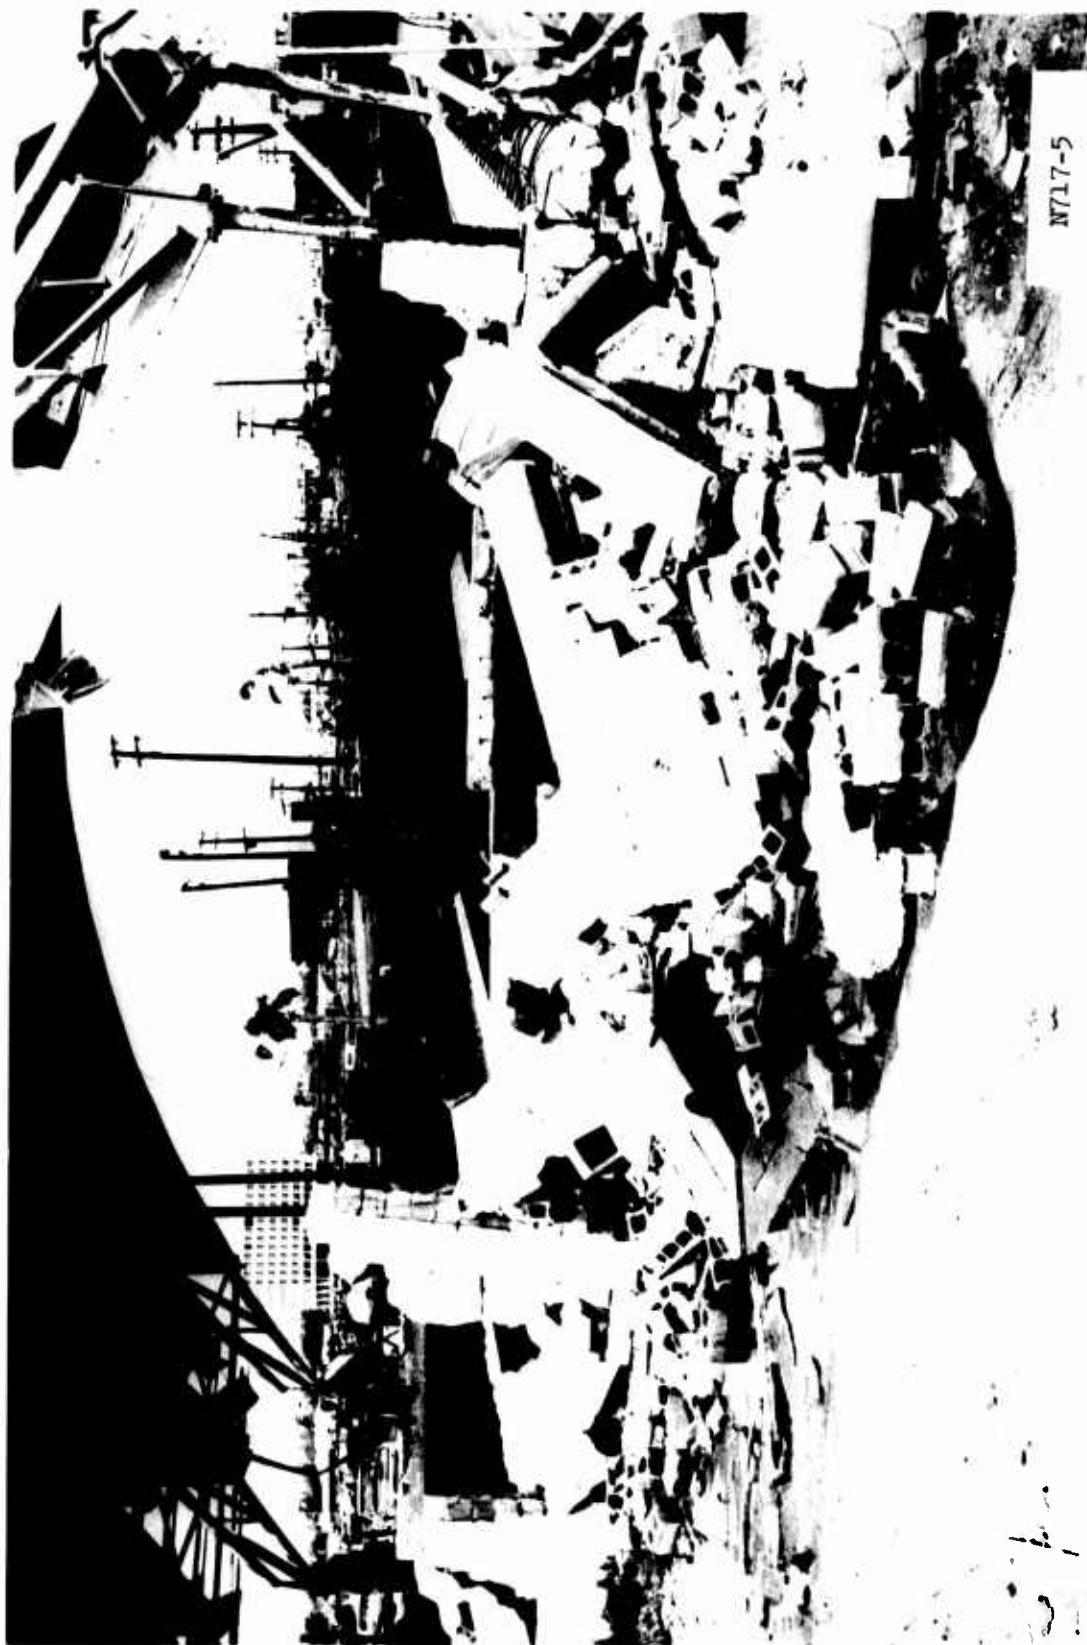
This seating area under the east side of the arch was completely collapsed (Figures 3.18 and 3.19). The seating area appeared to have failed when the water lifted the seating and dropped it onto the walls crushing some block and failing the beams of the seating portion at the supporting walls, thus transforming the beams into essentially simply supported spans which then fell (Figures 3.20 through 3.22). It was not clear whether these beams had been designed for continuity; the steel arrangement, but not the splice length, suggests that they were.

Figure 3.18 Seating area under Marine Life arch.

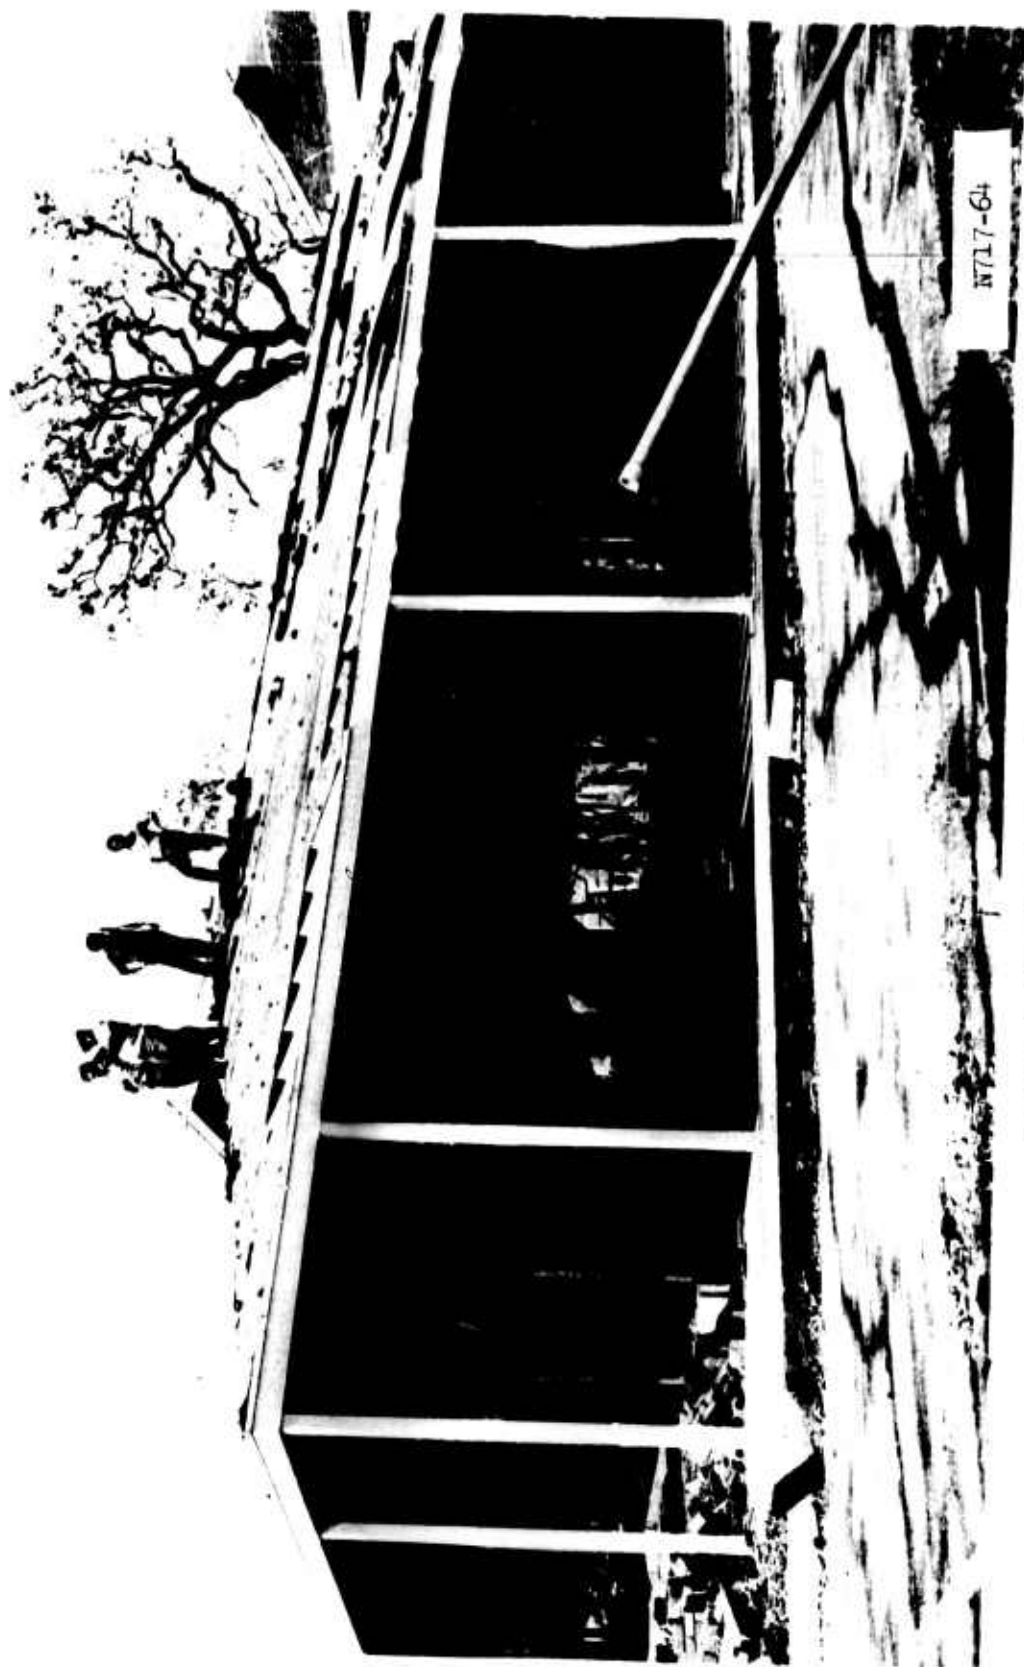
The main building (Figure 3.38) was parallel to the highway. There appeared to be two wings perpendicular to and behind the main building. The east wing was completely leveled and the west wing was relatively undamaged. The east wall of the main building was out (Figure 3.39), and the entire first floor suffered extensive water damage, especially in the dining area (Figure 3.40).

Figure 3.40 Ramada Inn dining area.

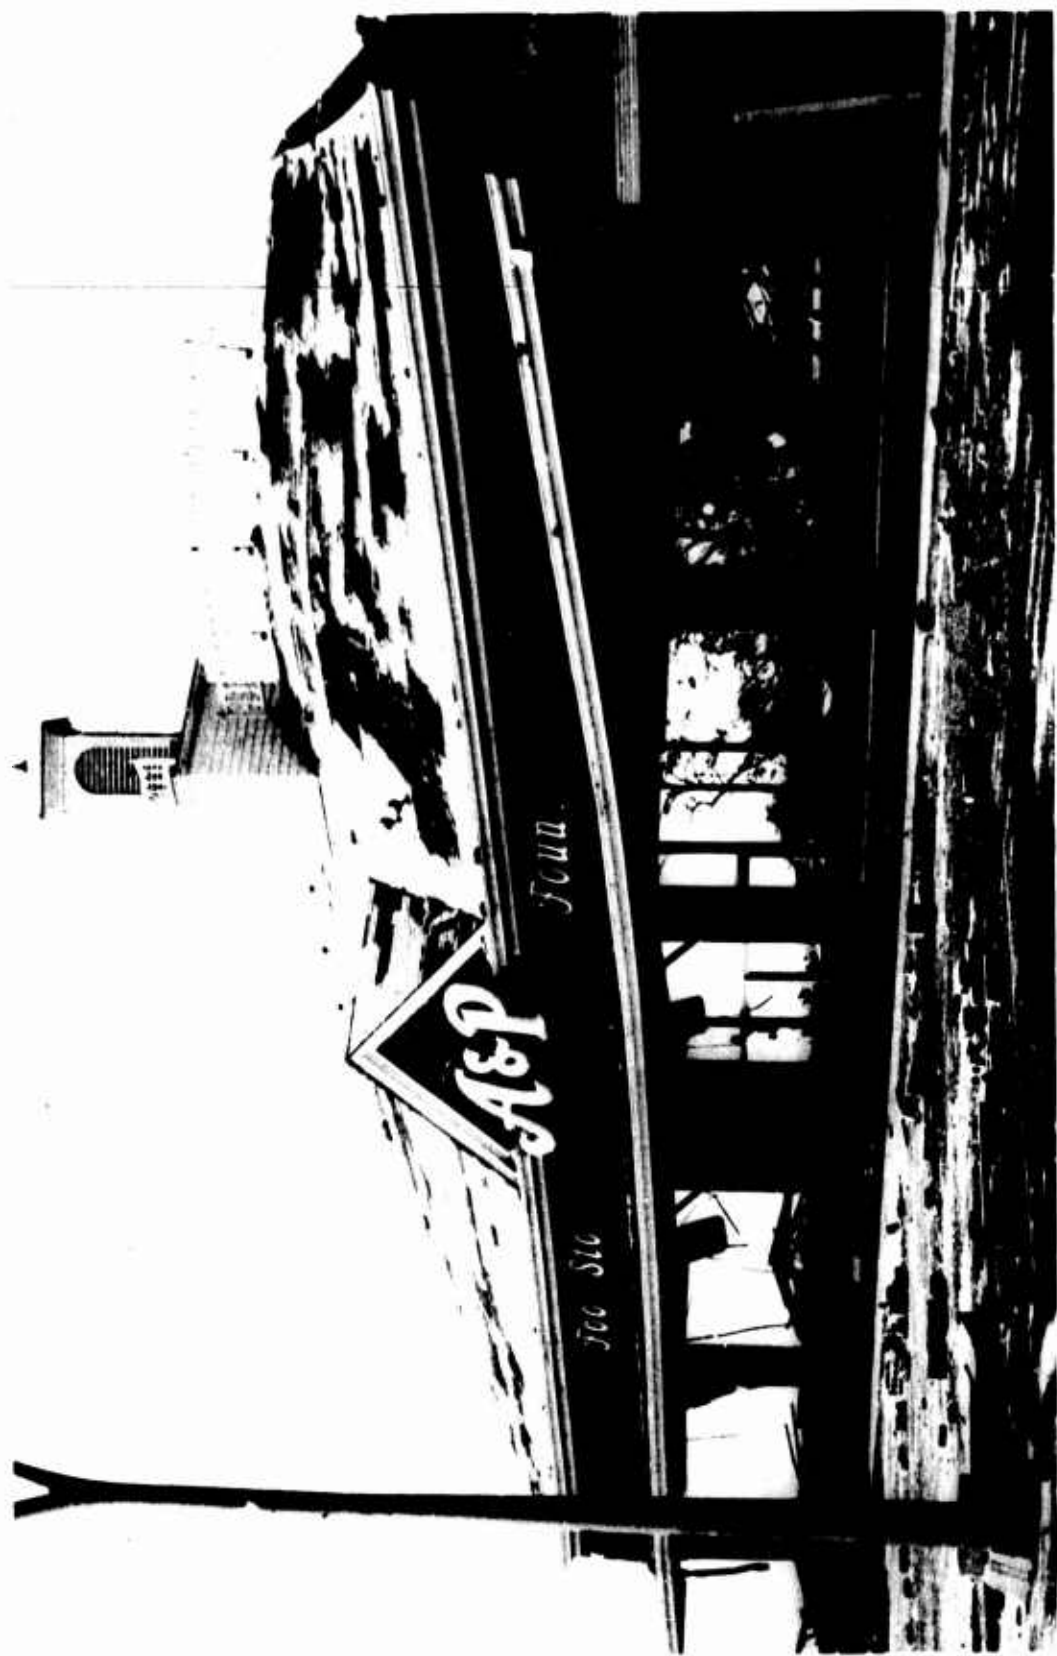
This complex, located several blocks east of the Ramada Inn in Long Beach, was constructed mainly of block walls, steel pipe columns and main beams, and with small angle trusses or bar joists supporting the roof. The front of the A&P store is shown in Figure 3.41.

Figure 3.41 Front of A&P store, Long Beach.

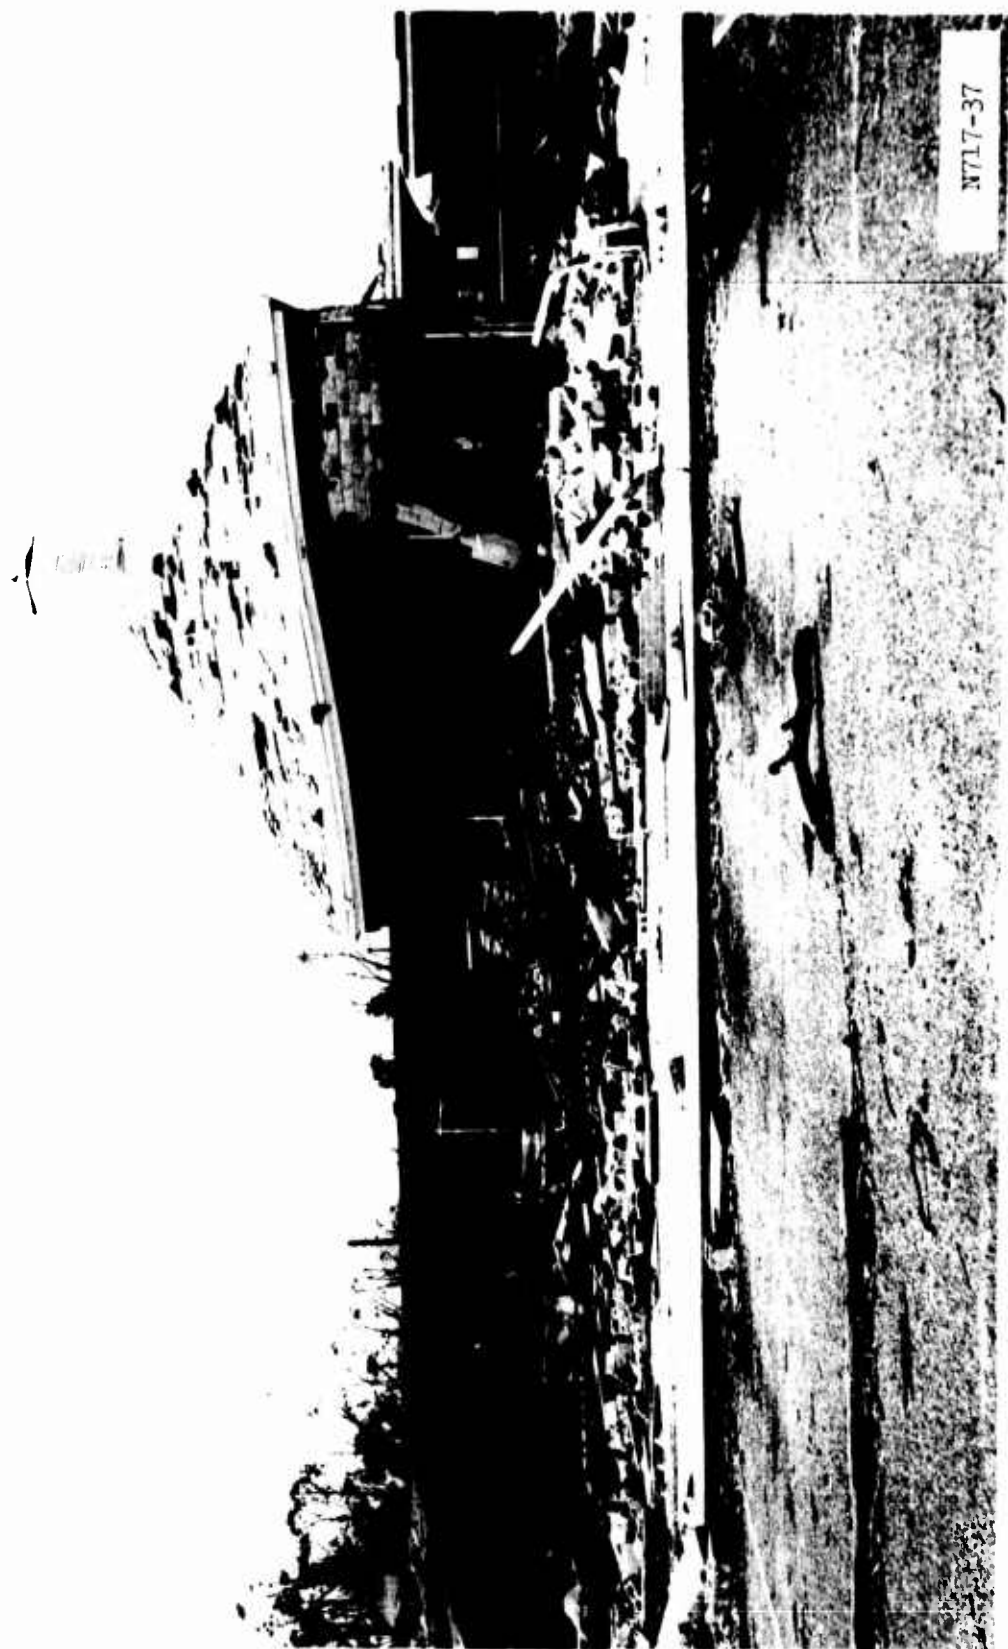
A Walgreen's store located on the seaward side of the A&P collapsed completely with much debris ending up in or behind the A&P (Figure 3.42). The angle trusses appeared to have been set into the block and brick exterior walls and fell with the wall. Small bulb angles placed atop the trusses and supporting the roofing panels spaced the trusses laterally.

Figure 3.42 Side view of A&P with remains of Walgreen's in foreground, Long Beach.

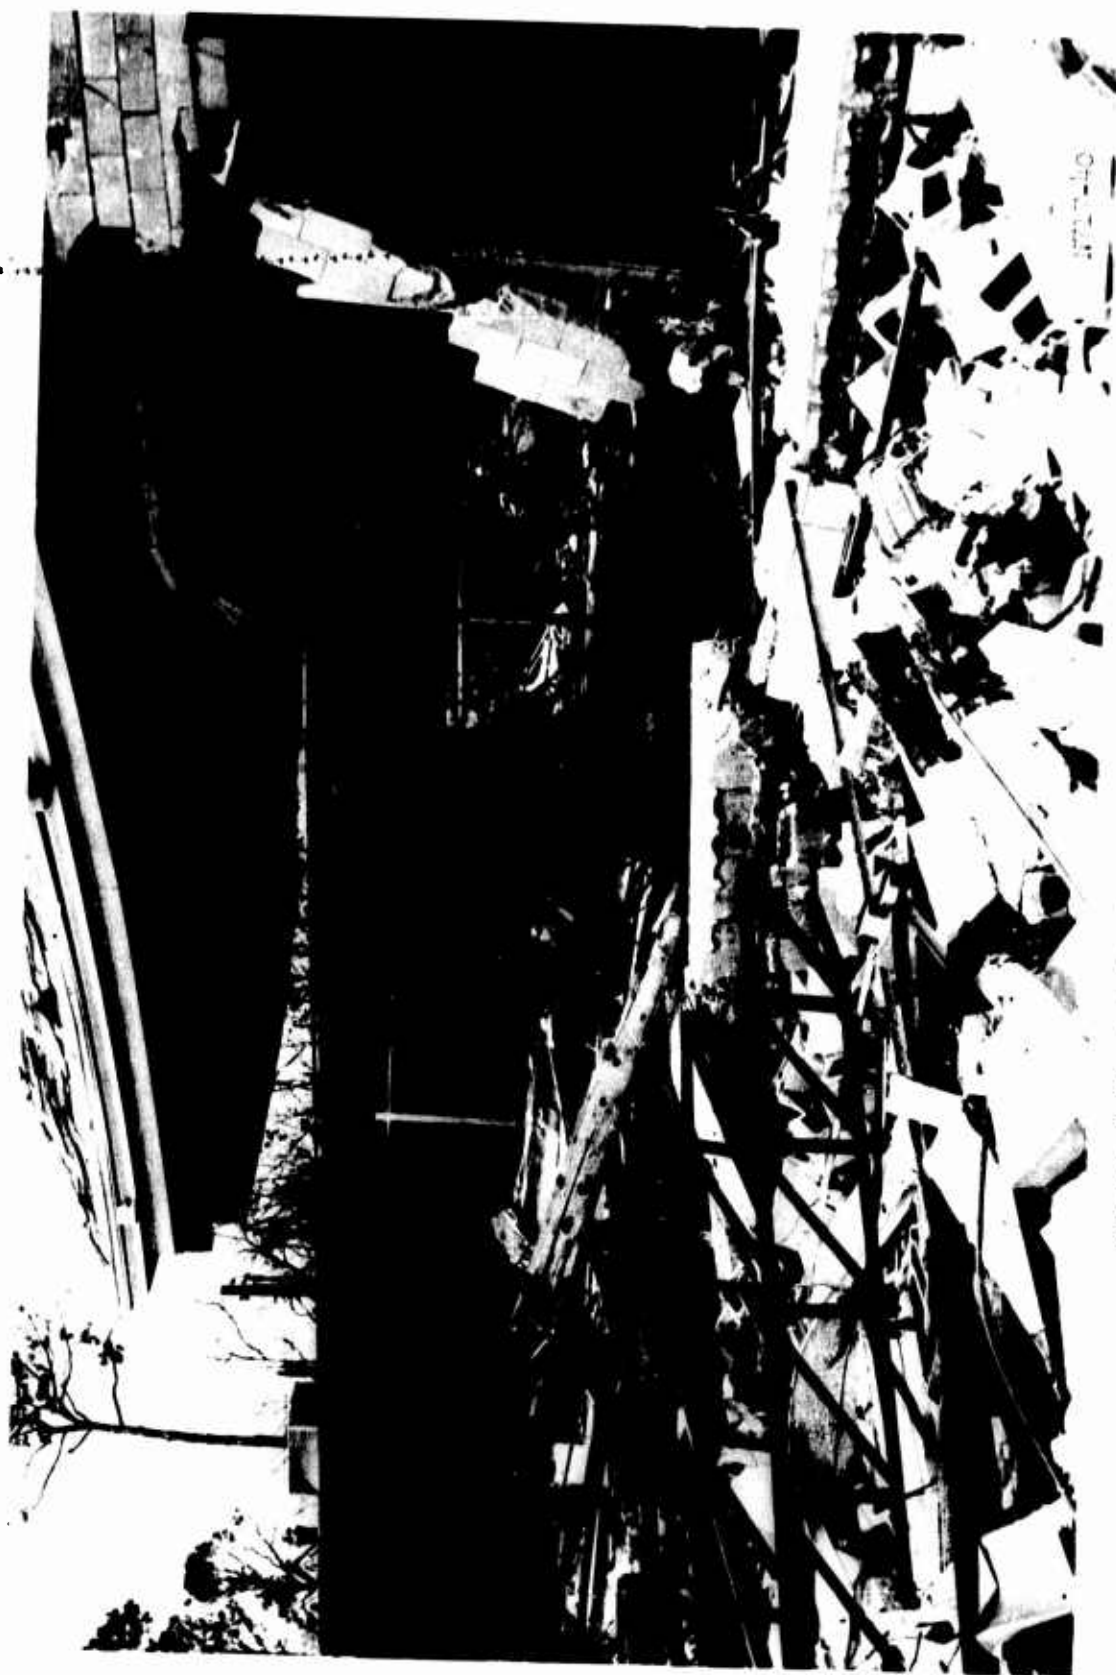
The two side bays of the A&P store collapsed, probably when the walls between this building and the adjoining stores were destroyed. One corner of the wooden truss hip roof at the front of the A&P was left cantilevered over the debris (Figure 3.43). The center bay, supported on steel beams at both ends, did not suffer extensive structural damage (Figure 3.44). The presence of lamps in the fixtures shows that the water did not reach the ceiling level.

Figure 3.43 Debris in A&P and Walgreen's stores.

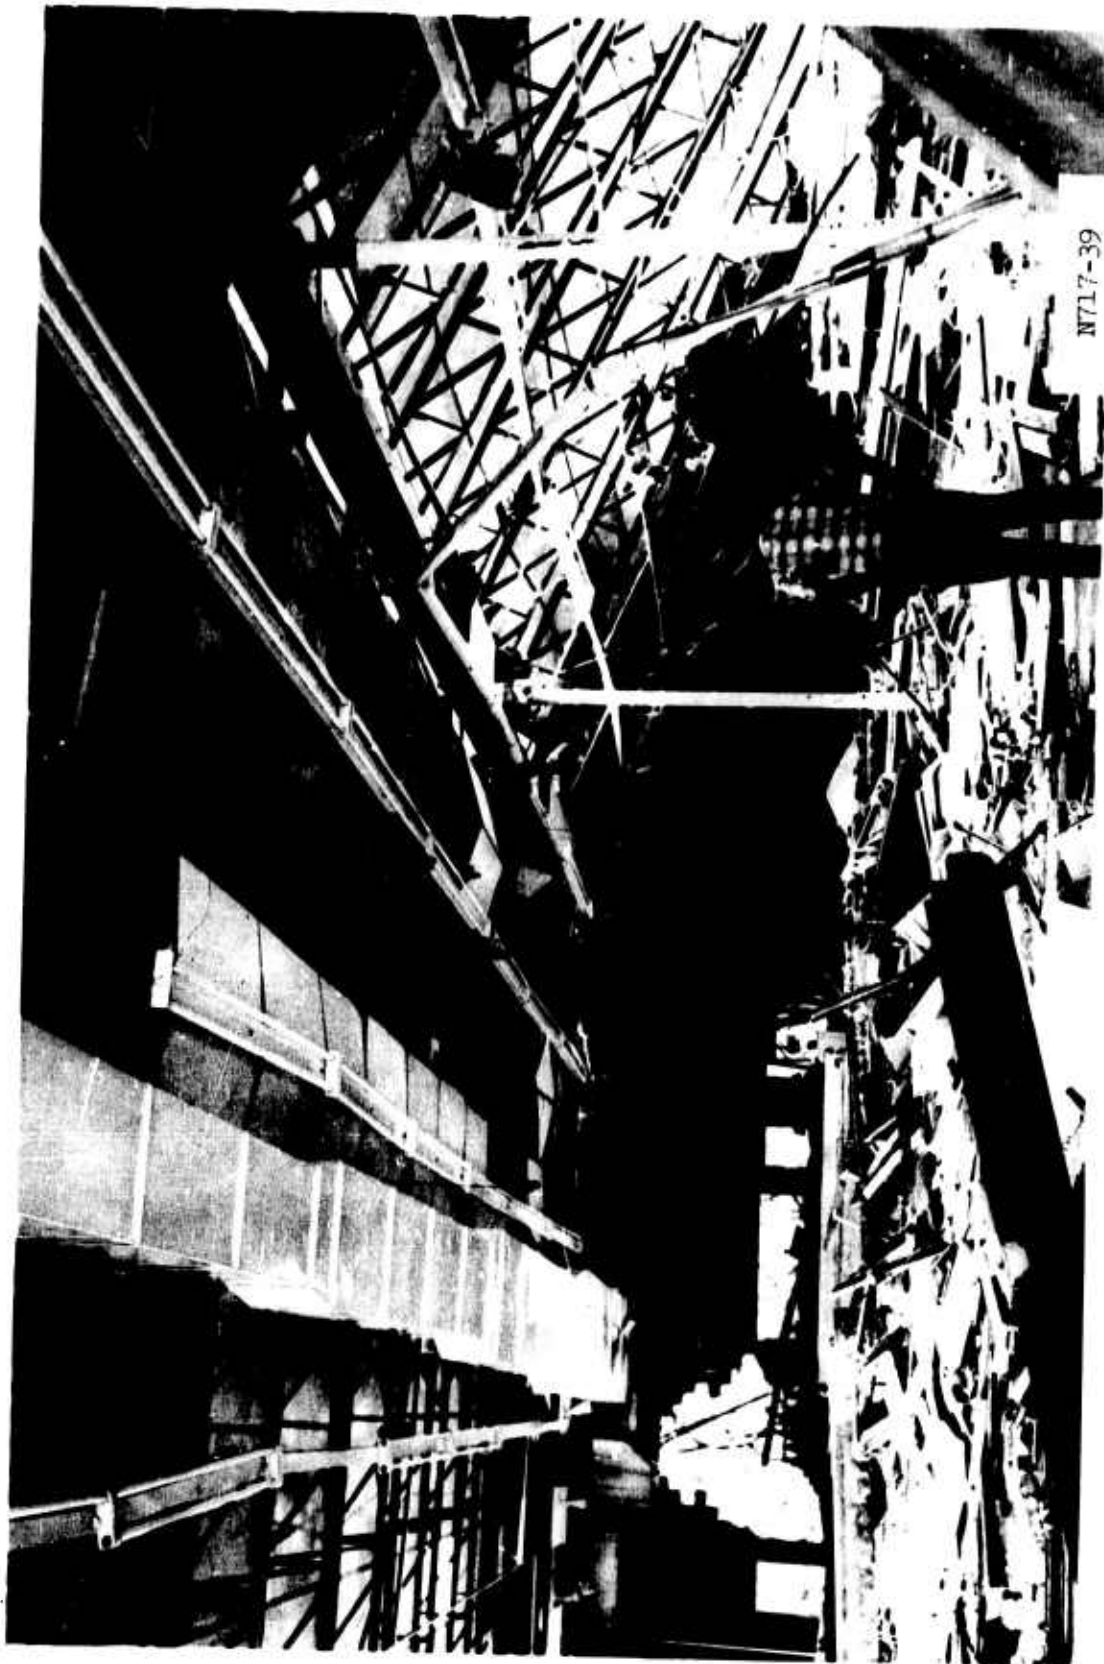
Figure 3.44 Central bay of A&P, Long Beach.

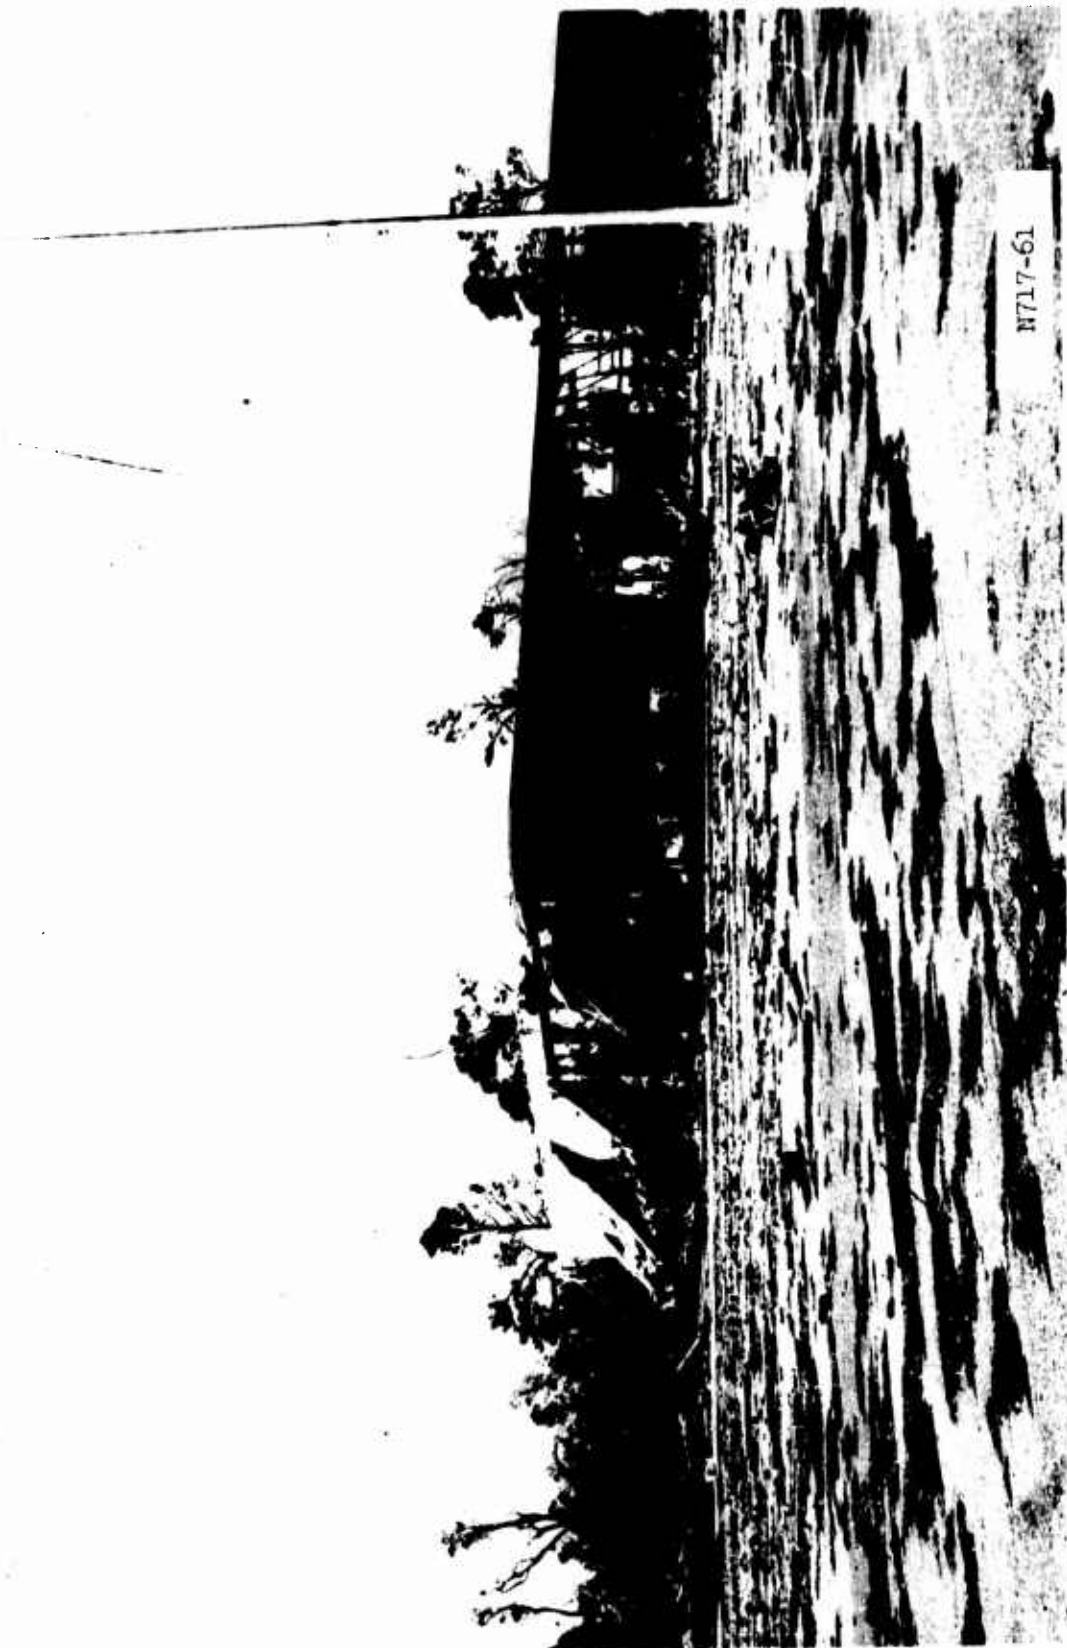
Several stores, including a large discount-type store, were located in Gulf Plaza near the Long Beach-Pass Christian boundary and contained in a large pipe column, beam, and bar joist structure with glass and block walls. As can be seen in Figures 3.46 and 3.47, the exterior walls and store contents were completely washed away, leaving only portions of the building frame. It appeared that only a minimum amount of welding had been used to attach the bar joists to the supporting beams.

Figure 3.46 Gulf Plaza shopping center.
